Report on Water Quality in the River Deben February 2024

This report from **The Deben Climate Centre** describes E.coli and phosphate pollution in the River Deben. It involved over 12 months of sampling and testing results from over 25 locations, with a particular focus on the impact that Waste Water Treatment Works (WWTW) have on pollution levels. These treatment works are owned and operated by Anglian Water but governed by standards set by the Environment Agency.

Report written by Bill Brammar PhD and David Findley PhD
Published 9th February 2024

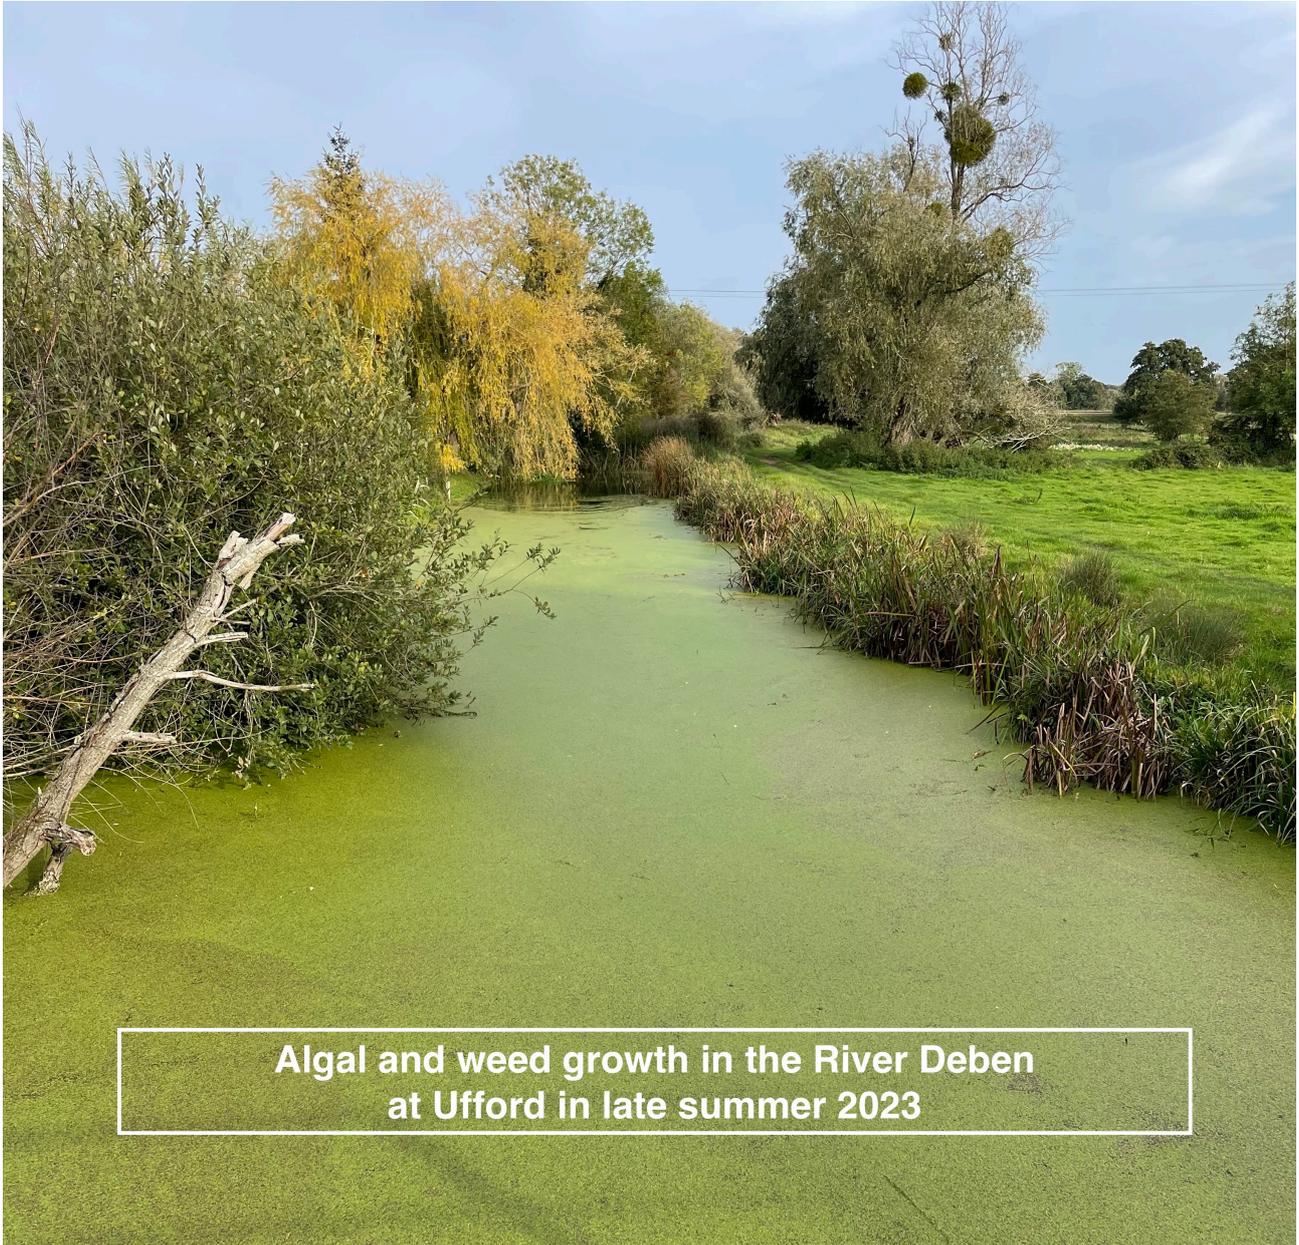
Algal and weed growth in the River Deben
at Ufford in late summer 2023
